Utility Conflict Report

OWNER	Utility	CPS	Corridor	SW MILITARY	SITE PHOTOS	
	Contact	JAKE MARTINEZ	ID	7036		
GENERAL INFO	Utility	ELECTRIC

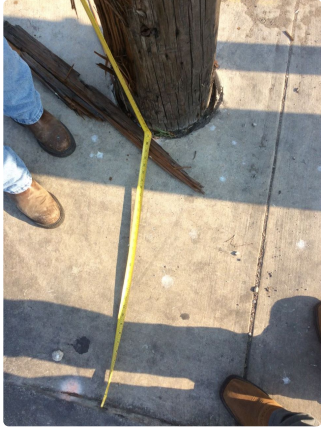
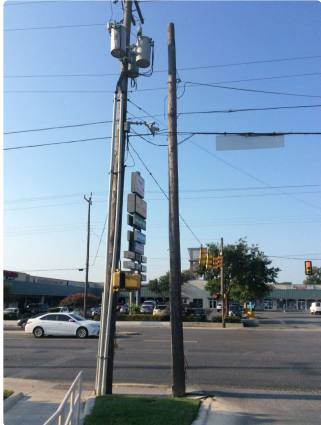
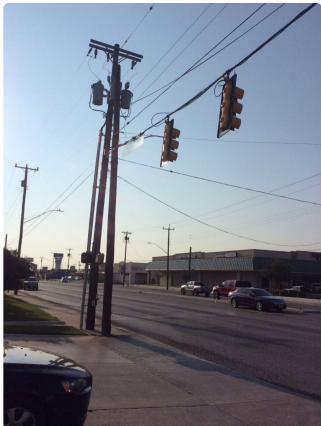
Size and Material	STANDARD POWER POLE, TIMBER				
	Accessible Route	ASSET IS INSIDE ACCESSIBLE ROUTE				
	Longitudinal or Crossing	CROSSING				
	Placement Relative to ROW	INSIDE ROW				
LOCATION	Sheet No.	211

Station	947+53.22				
	Offset	-17.74				
	Latitude	+29.356862				
	Longitude	-98.50156				
SUE	Level of Investigation Req'd	NONE

Test Hole No	N/A				
	Test Hole Depth	N/A				
RESOLUTION	Recommended Action	NO CONFLICT				
	Estimated Resolution Date					
	Resolution Status	NO RESOLUTION WAS REQUIRED				
	Comment	Back of curb to pole = 2'-9" Pole diameter = 12" Pole to edge of driveway = 20"				
Date Collected		8/3/2018 8:40:05 AM		Date Modified	12/18/2018 4:01:17 PM
