## Utility Conflict Report

<b>OWNER</b>	<b>Utility</b>	SAWS	<b>Corridor</b>	SW MILITARY	<b>SITE PHOTOS</b>

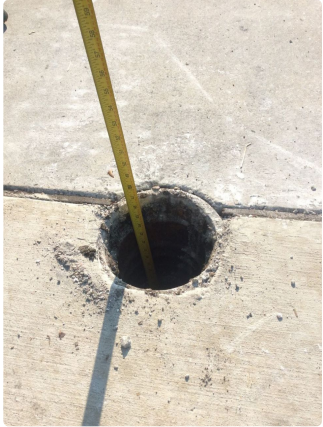
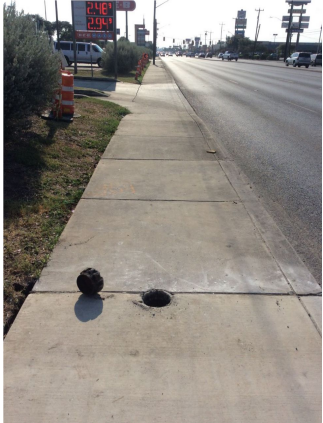
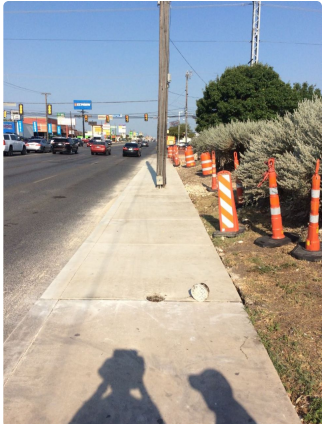
<b>Size and Material</b>	STANDARD WATER VALVE, CAST IRON				
	<b>Accessible Route</b>	ASSET IS INSIDE ACCESSIBLE ROUTE				
	<b>Longitudinal or Crossing</b>	CROSSING				
	<b>Placement Relative to ROW</b>	INSIDE ROW				
<b>LOCATION</b>	<b>Sheet No.</b>	210

<b>Station</b>	942+01.55				
	<b>Offset</b>	-16.97				
	<b>Latitude</b>	+29.356786				
	<b>Longitude</b>	-98.50328				
<b>SUE</b>	<b>Level of Investigation Req'd</b>	NONE				
	<b>Test Hole No</b>	N/A				
	<b>Test Hole Depth</b>	N/A				
<b>RESOLUTION</b>	<b>Recommended Action</b>	NO CONFLICT				
	<b>Estimated Resolution Date</b>					
	<b>Resolution Status</b>	NO RESOLUTION WAS REQUIRED				
	<b>Comment</b>	Top of valve to surface = 45.5" Lid thickness = 2" lid Back of curb to valve = 2'-10"
