Utility Conflict Report

OWNER	Utility	CPS	Corridor	SW MILITARY	SITE PHOTOS		
	Contact	JAKE MARTINEZ	ID	7048			
GENERAL INFO	Utility	ELECTRIC

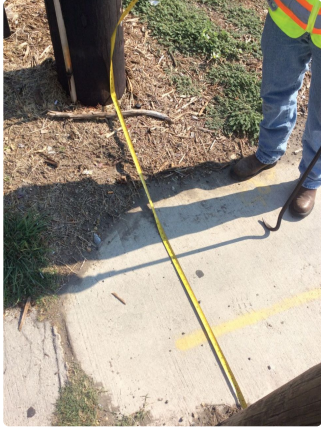
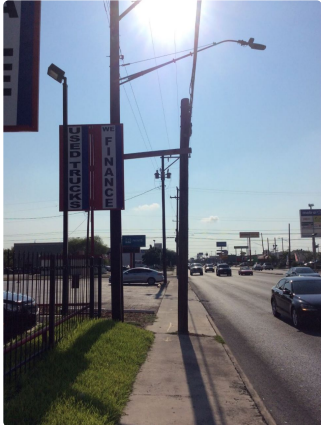
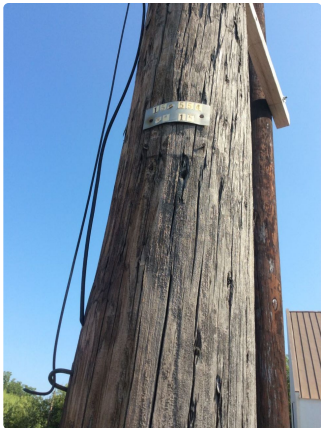
Size and Material	STANDARD POWER POLE, TIMBER					
	Accessible Route	ASSET IS INSIDE ACCESSIBLE ROUTE					
	Longitudinal or Crossing	CROSSING					
	Placement Relative to ROW	INSIDE ROW					
LOCATION	Sheet No.	208

Comment	2 power poles (front and back) Front pole to back pole = 5'-0" Front pole to back of sidewalk = 2'-8" Pole diameters = 10" Back of curb to front pole = 2'-6" Back pole ID: 386932					
Date Collected		8/3/2018 9:51:06 AM		Date Modified		12/18/2018 4:01:24 PM

Test Hole No	N/A					
	Test Hole Depth	N/A					
RESOLUTION	Recommended Action	NO CONFLICT					
	Estimated Resolution Date						
	Resolution Status	NO RESOLUTION WAS REQUIRED
