Utility Conflict Report

OWNER	Utility	SAWS	Corridor	SW MILITARY	SITE PHOTOS	
	Contact	ANN PECHE	ID	7071		
GENERAL INFO	Utility	WATER

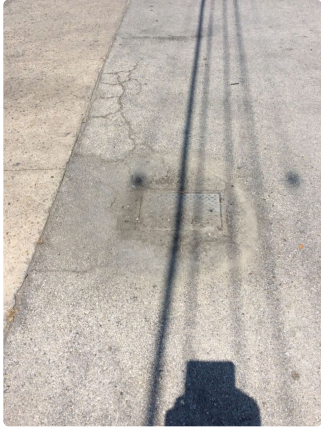
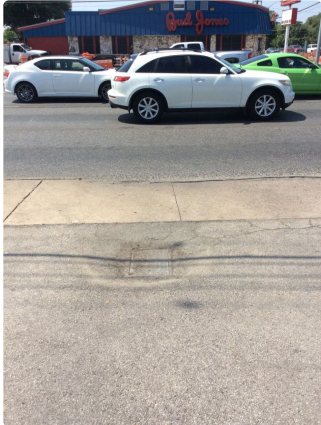
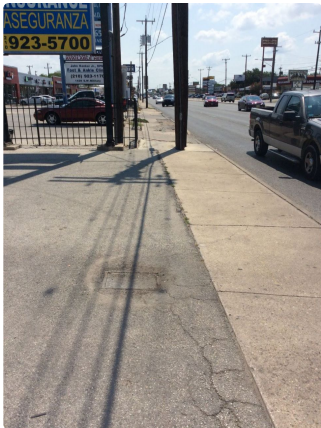
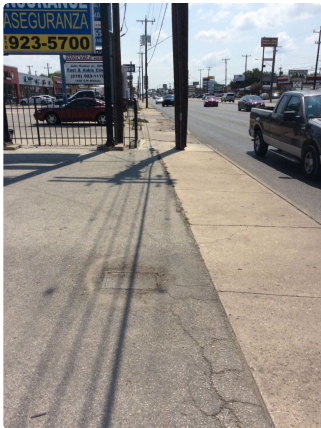
Size and Material	STANDARD WATER METER, STEEL				
	Accessible Route	ASSET IS OUTSIDE ACCESSIBLE ROUTE				
	Longitudinal or Crossing	CROSSING				
	Placement Relative to ROW	INSIDE ROW				
LOCATION	Sheet No.	155

Estimated Resolution Date					
	Resolution Status	UTILITY OWNER INFORMED OF UTILITY				
	Comment	Unable to open lid Meter to driveway joint = 1'-7"				
Date Collected		8/3/2018 11:46:04 AM		Date Modified 11/28/2018 6:59:12 AM

Test Hole No	N/A				
	Test Hole Depth	N/A				
RESOLUTION	Recommended Action	MINIMIZE - PROTECT IN PLACE
