Utility Conflict Report

OWNER	Utility	SAWS	Corridor	SW MILITARY	SITE PHOTOS		
	Contact	ANN PECHE	ID	7074			
GENERAL INFO	Utility	WATER

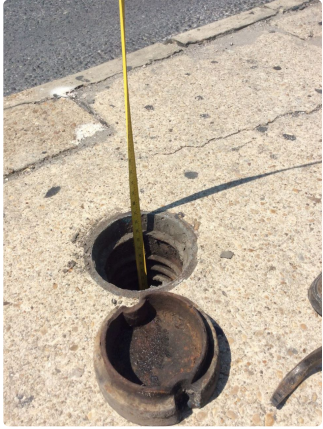
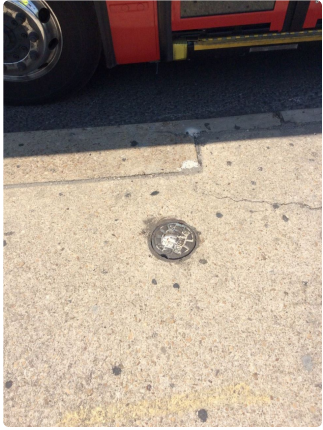
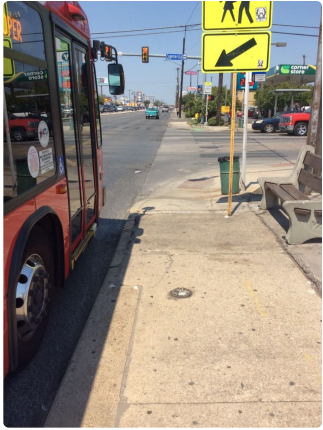
Size and Material	STANDARD WATER VALVE, CAST IRON					
	Accessible Route	ASSET IS INSIDE ACCESSIBLE ROUTE					
	Longitudinal or Crossing	CROSSING					
	Placement Relative to ROW	INSIDE ROW					
LOCATION	Sheet No.	155

Test Hole No	N/A					
	Test Hole Depth	N/A					
RESOLUTION	Recommended Action	NO CONFLICT					
	Estimated Resolution Date						
	Resolution Status	NO RESOLUTION WAS REQUIRED					
	Comment	Back of curb inlet to valve = 11" Top of valve to surface = 2'-6" Lid thickness = 2"					
Date Collected		8/3/2018 11:54:22 AM		Date Modified		12/18/2018 4:31:53 PM
