## Utility Conflict Report

<b>OWNER</b>	<b>Utility</b>	SAWS	<b>Corridor</b>	SW MILITARY	<b>SITE PHOTOS</b>	
	<b>Contact</b>	ANN PECHE	<b>ID</b>	7094		
<b>GENERAL INFO</b>	<b>Utility</b>	WATER

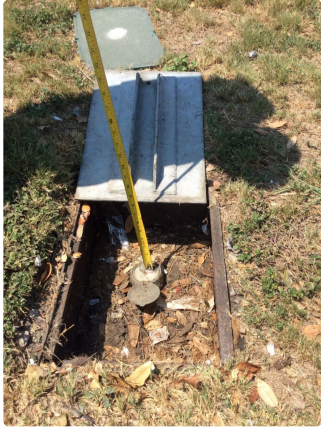
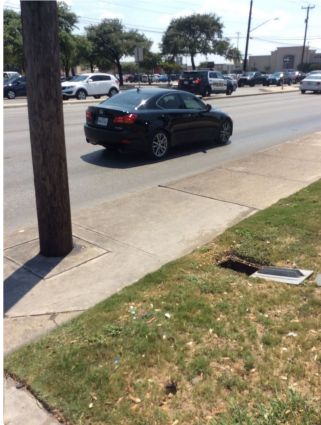
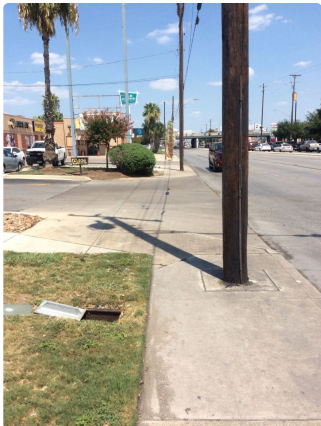
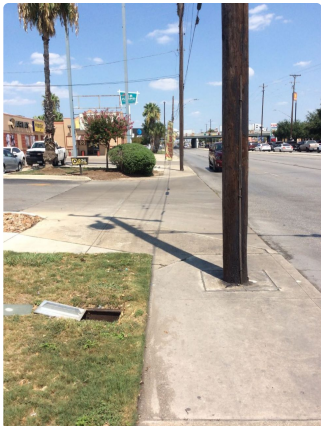
<b>Size and Material</b>	STANDARD WATER METER, STEEL				
	<b>Accessible Route</b>	ASSET IS OUTSIDE ACCESSIBLE ROUTE				
	<b>Longitudinal or Crossing</b>	CROSSING				
	<b>Placement Relative to ROW</b>	INSIDE ROW				
<b>LOCATION</b>	<b>Sheet No.</b>	197

<b>Estimated Resolution Date</b>					
	<b>Resolution Status</b>	UTILITY OWNER INFORMED OF UTILITY				
	<b>Comment</b>	Back of sidewalk to meter = 11" Top of meter to surface = 6" Lid thickness = 1/4"

<b>Test Hole No</b>	N/A				
	<b>Test Hole Depth</b>	N/A				
<b>RESOLUTION</b>	<b>Recommended Action</b>	MINIMIZE - PROTECT IN PLACE
