## Utility Conflict Report

<b>OWNER</b>	<b>Utility</b>	SAWS	<b>Corridor</b>	SW MILITARY	<b>SITE PHOTOS</b>	
	<b>Contact</b>	ANN PECHE	<b>ID</b>	7117		
<b>GENERAL INFO</b>	<b>Utility</b>	WATER

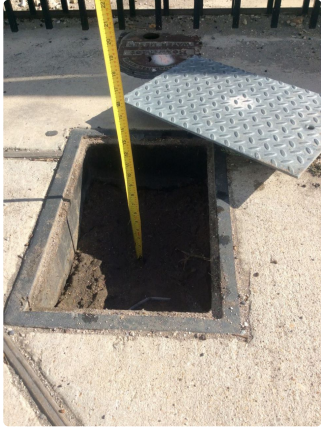
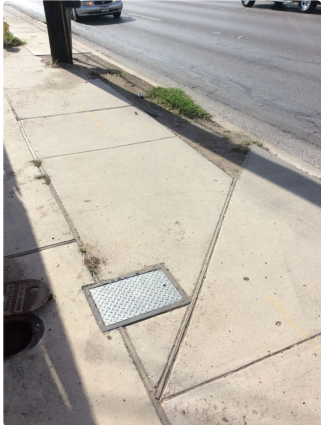
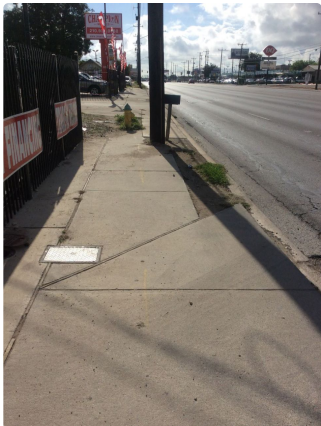
<b>Size and Material</b>	STANDARD WATER METER, STEEL				
	<b>Accessible Route</b>	ASSET IS INSIDE ACCESSIBLE ROUTE				
	<b>Longitudinal or Crossing</b>	CROSSING				
	<b>Placement Relative to ROW</b>	INSIDE ROW				
<b>LOCATION</b>	<b>Sheet No.</b>	186

<b>Station</b>	786+47.90				
	<b>Offset</b>	-19.52				
	<b>Latitude</b>	+29.357701				
	<b>Longitude</b>	-98.55165				
<b>SUE</b>	<b>Level of Investigation Req'd</b>	NONE

<b>Test Hole No</b>	N/A				
	<b>Test Hole Depth</b>	N/A				
<b>RESOLUTION</b>	<b>Recommended Action</b>	MINIMIZE - PROTECT IN PLACE				
	<b>Estimated Resolution Date</b>					
	<b>Resolution Status</b>	UTILITY OWNER INFORMED OF UTILITY				
	<b>Comment</b>	Top of meter to surface = 7" Fence to meter = 1'-8" Meter adjacent to back of sidewalk
