Utility Conflict Report

| OWNER | Utility | CPS | Corridor | SW MILITARY | SITE PHOTOS | |
| | Contact | JAKE MARTINEZ | ID | 7128 | | |

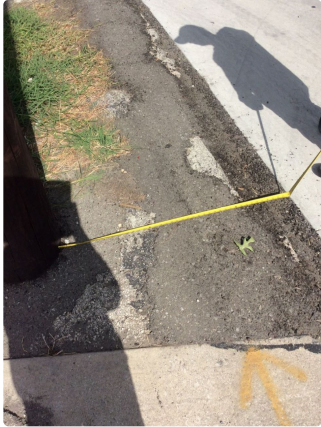
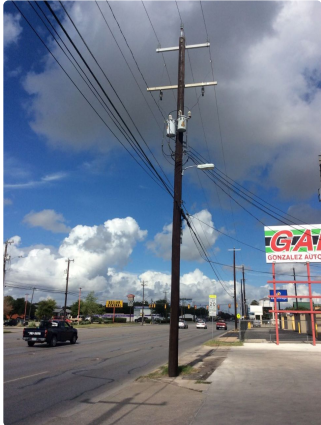
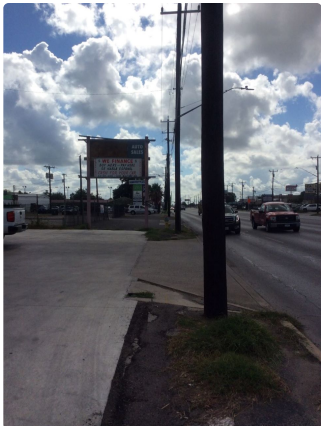
| | Size and Material | STANDARD POWER POLE, TIMBER | | | | |
| | Accessible Route | ASSET IS OUTSIDE ACCESSIBLE ROUTE | | | | |
| | Longitudinal or Crossing | CROSSING | | | | |
| | Placement Relative to ROW | INSIDE ROW | | | | |
| | Station | 782+85.50 | | | | |
| | Offset | -16.24 | | | | |
| | Comment | Pole ID: 458752 Edge of concrete to pole = 3'-6" Pole diameter = 12" Back of curb to pole = 2'-6" | | | | |

| RESOLUTION | Recommended Action | NO CONFLICT | | | | |
| | Resolution Status | NO RESOLUTION WAS REQUIRED | | | | |
