Utility Conflict Report

OWNER	Utility	CPS	Corridor	SW MILITARY	SITE PHOTOS	
	Contact	JAKE MARTINEZ	ID	7131		
GENERAL INFO	Utility	ELECTRIC

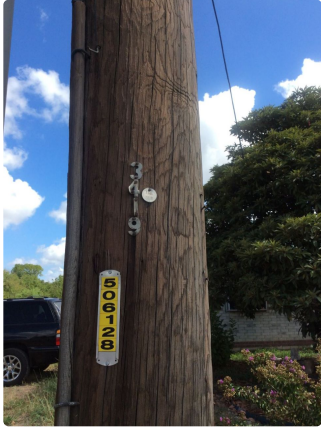
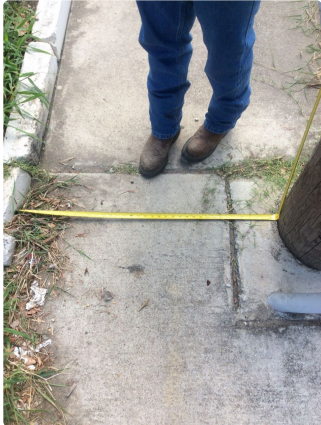
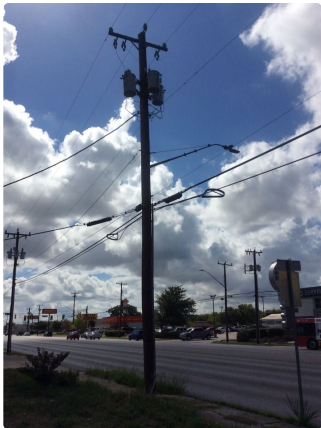
Size and Material	STANDARD POWER POLE, TIMBER				
	Accessible Route	ASSET IS INSIDE ACCESSIBLE ROUTE				
	Longitudinal or Crossing	CROSSING				
	Placement Relative to ROW	INSIDE ROW				
LOCATION	Sheet No.	183

Station	776+15.54				
	Offset	-16.94				
	Latitude	+29.358047				
	Longitude	-98.55526				
SUE	Level of Investigation Req'd	NONE

Test Hole No	N/A				
	Test Hole Depth	N/A				
RESOLUTION	Recommended Action	NO CONFLICT				
	Estimated Resolution Date	11/21/2018				
	Resolution Status	NO RESOLUTION WAS REQUIRED				
	Comment	Pole ID: 506128 Pole diameter = 12" Front of sidewalk to pole = 1'-2" Back of sidewalk to pole = 3'-1"				
Date Collected		8/6/2018 10:53:58 AM		Date Modified	11/28/2018 6:59:12 AM
