Utility Conflict Report

OWNER	Utility	CPS	Corridor	SW MILITARY	SITE PHOTOS

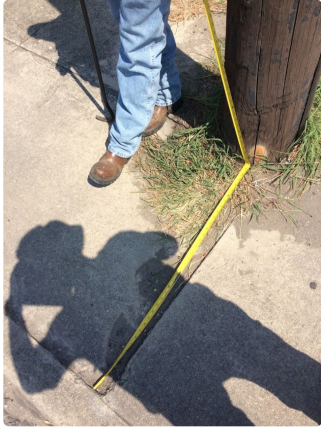
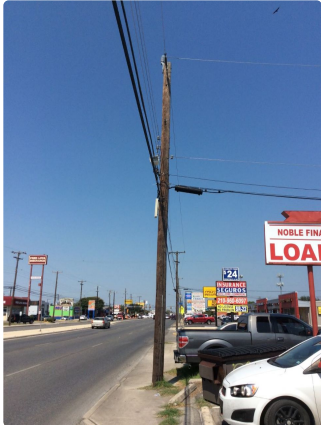
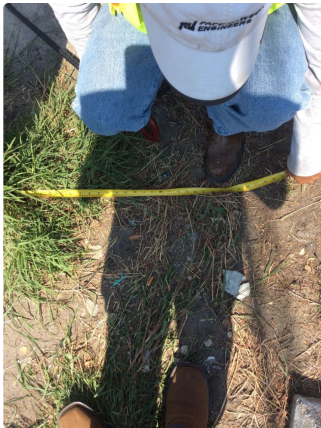
Contact	JAKE MARTINEZ	ID	7063	
GENERAL INFO	Utility	ELECTRIC			
	Size and Material	STANDARD POWER POLE, TIMBER			
	Accessible Route	ASSET IS INSIDE ACCESSIBLE ROUTE			
	Longitudinal or Crossing	CROSSING			
	Placement Relative to ROW	INSIDE ROW			
LOCATION	Sheet No.	200			
	Station	907+71.08			
	Offset	-17.42			
	Latitude	+29.356786			
	Longitude	-98.51405			
SUE	Level of Investigation Req'd	NONE			
	Test Hole No	N/A			
	Test Hole Depth	N/A			
RESOLUTION	Recommended Action	ACCOMMODATE - RELOCATION			
	Estimated Resolution Date				
	Resolution Status	UTILITY OWNER INFORMED OF UTILITY

Comment	Pole ID: 501991 Back of curb to pole = 3'-1" Pole diameter = 10" Pole to back of sidewalk = 2'-0" Relocate pole to ROW with electric lines cantilevered toward the roadway			
Date Collected		8/3/2018 11:17:59 AM		Date Modified	11/21/2018 2:51:37 PM
