Utility Conflict Report

OWNER	Utility	SAWS	Corridor	NOGALITOS	SITE PHOTOS		
	Contact	NINA BITTLE	ID	3056			
GENERAL INFO	Utility	WATER

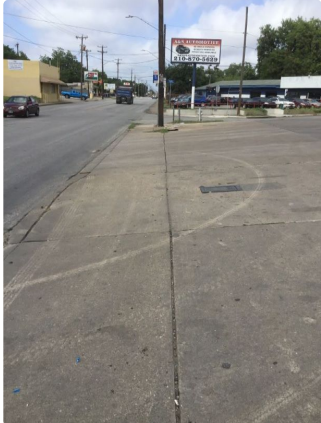
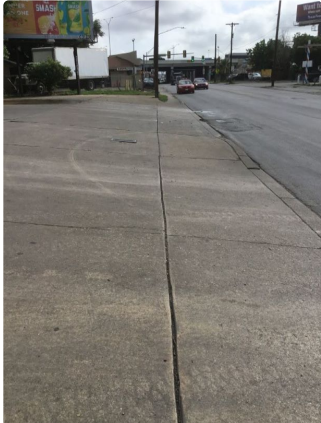
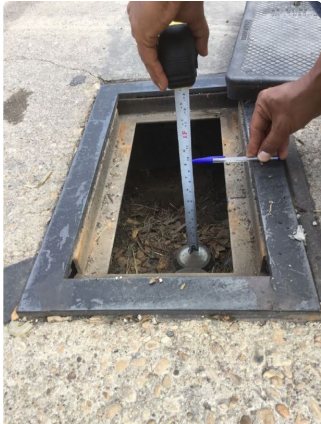
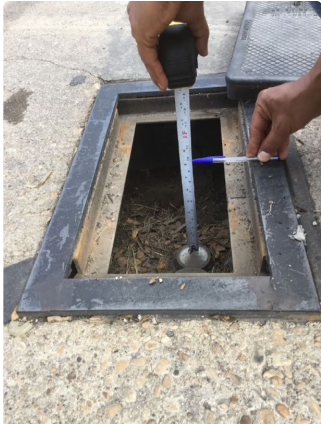
Size and Material	STANDARD WATER METER, STEEL					
	Accessible Route	ASSET IS OUTSIDE ACCESSIBLE ROUTE					
	Longitudinal or Crossing	CROSSING					
	Placement Relative to ROW	INSIDE ROW					
LOCATION	Sheet No.

Estimated Resolution Date	8/13/2018					
	Resolution Status	NO RESOLUTION WAS REQUIRED					
	Comment	Top of meter to surface = 10" Meter to back of sidewalk = 1'-9" Sidewalk width = 5'-8" Rubber lid thickness = 2"					
Date Collected		7/11/2018 9:35:26 AM		Date Modified		8/14/2018 4:38:26 PM

Test Hole No	N/A					
	Test Hole Depth	N/A					
RESOLUTION	Recommended Action	NO CONFLICT
