Utility Conflict Report

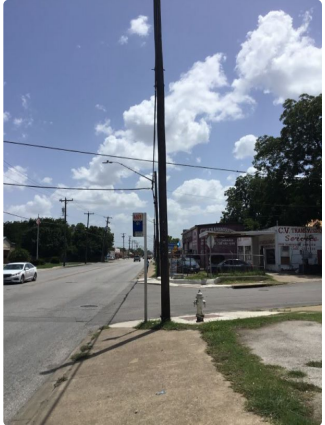
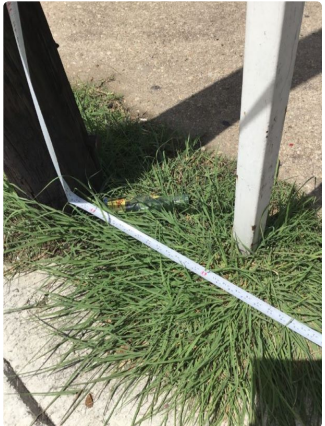
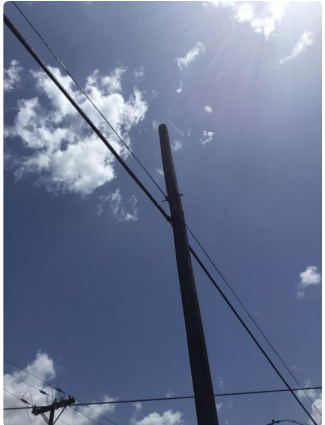
OWNER	Utility	CPS	Corridor	NOGALITOS	SITE PHOTOS		
	Contact	JAKE MARTINEZ	ID	4077			
GENERAL INFO	Utility	ELECTRIC					
	Size and Material	STANDARD POWER POLE, TIMBER					
	Accessible Route	ASSET IS OUTSIDE ACCESSIBLE ROUTE					
	Longitudinal or Crossing	CROSSING					
	Placement Relative to ROW	INSIDE ROW					
LOCATION	Sheet No.						
	Station	132+99.53					
	Offset	-28.6542					
	Latitude	+29.393377					
	Longitude	-98.51785					
SUE	Level of Investigation Req'd	NONE					
	Test Hole No	N/A					
	Test Hole Depth	N/A					
RESOLUTION	Recommended Action	NO CONFLICT					
	Estimated Resolution Date	8/13/2018					
	Resolution Status	NO RESOLUTION WAS REQUIRED

Comment	Pole diameter = 8" Pole to back of curb = 5'-2" Sidewalk width = 3'-8" VIA bus stop sign to back of curb = 3'-8" Adjacent to VIA bus stop no. 62447					
Date Collected		7/10/2018 3:03:14 PM		Date Modified		8/14/2018 4:38:26 PM
