CITY OF SAN MARCOS ADA TRANSITION PLAN SIGNALIZED INTERSECTION ASSESSMENT AND COMPLIANCE REPORT

Location ID: 000000072
 North-South Cross Street: LEAH AVE
 East-West Cross Street: WONDER WORLD DR

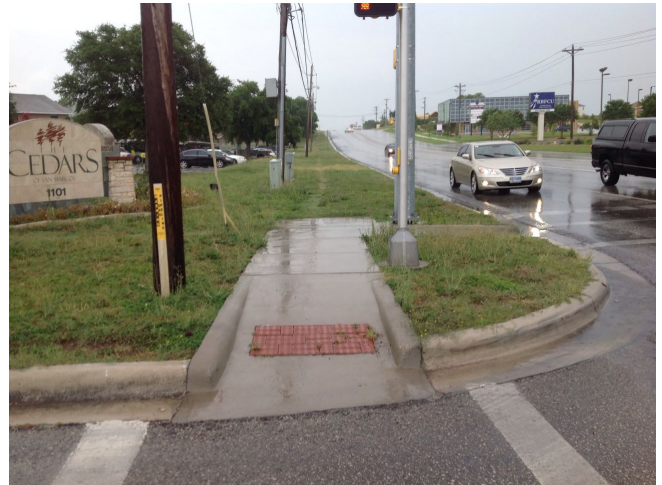
Signalized Intersection: YES
 Accessible Features: YES
 Pedestrian Features Accessible: YES

Ramp Elements	Curb ramp provided where an accessible route crosses a barrier:	YES
	Is the slope of the ramp 1:12 or less:	NO
	Transition from curb ramp slope to roadway free from abrupt changes, no greater than 1:20:	YES
	Ramp is at least 36" wide:	YES
	Ramp surface is stable, firm, and slip resistant:	YES
Flare	Flares (if present) are 1:10 or less measured along the curb line; or If landing at top of ramp is not provided flares are 1:12 or less:	N/A
Detectable Warning Surface	Curb ramp is located such that it does not project into roadway or parking aisles:	N/A
	Detectable warning is present:	NO
	DWS maintains correct geometric controls; 0.9" diameter domes, 0.2" in height, spaced at 2.35" and visually contrasts adjacent ramp surface:	YES
Special Ramps	Ramp maintains defined edges parallel to direction of pedestrian travel; maintains 4'x4' turning pad contained in crosswalk; flared sides 24" segment on each side of ramp within crosswalk lines:	N/A

Ramp is located so they will not be obstructed by parked vehicles:	N/A
	Ramp wholly contained within the crosswalk lines:	YES
	If island is present; Island maintains a cut through at street level or ramps on either side with landing between them:	N/A
