## CITY OF SAN MARCOS ADA TRANSITION PLAN SIGNALIZED INTERSECTION ASSESSMENT AND COMPLIANCE REPORT

Location ID: 000000202 North-South Cross Street: LEAH East-West Cross Street: WONDER WORLD Location Details

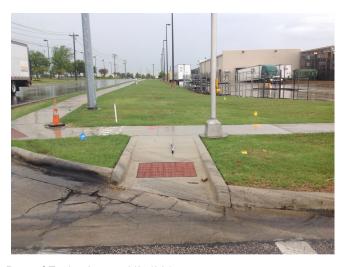
Ramp Elements	Curb ramp provided where an accessible route crosses a barrier:	YES
	Is the slope of the ramp 1:12 or less:	NO
	Transition from curb ramp slope to roadway free from abrupt changes, no greater than 1:20:	NO
	Ramp is at least 36" wide:	YES
	Ramp surface is stable, firm, and slip resistant:	YES
Flare	Flares (if present) are 1:10 or less measured along the curb line; or If landing at top of ramp is not provided flares are 1:12 or less:	N/A
Detectable Warning Surface	Curb ramp is located such that it does not project into roadway or parking aisles:	N/A
	Detectable warning is present:	NO
	DWS maintains correct geometric controls; 0.9" diameter domes, 0.2" in height, spaced at 2.35" and visually contracts adjacent ramp surface:	YES
Special Ramps	Ramp maintains defined edges parallel to direction of pedestrian travel; maintains 4'x4' turning pad contained in crosswalk; flared sides 24" segment on each side of ramp within crosswalk lines:	N/A
